Physical and cyber safety in critical water infrastructure
 NATO Advanced Research Workshop
 Oslo, Norway, 8-11 October 2018

**Possible application of
 EARLY WARNING SYSTEM (EWS)
 in the regional water management planning**

8-11 October 2018, Oslo, Norway

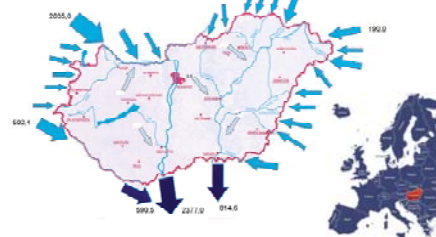
INFLOW – 24 rivers entering into the country

OUTFLOW – 3 rivers leaving the country

In Hungary 96% of the surface water comes from neighbouring countries.

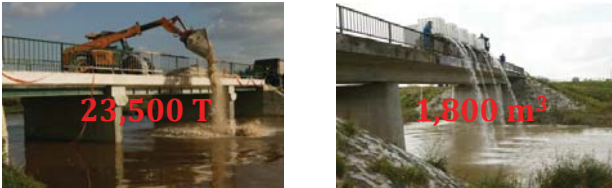
The water management task force initially focused on neutralising the caustic surface waters with addition of acids (e.g. acetic acid, hydrochloric acid) and gypsum into the Stream Torna, Rivers Marcal and Rába in order to avoid the contamination of the River Danube.

- ✓ To neutralize the strong alkaline pH gypsum was added starting from October 5, 2010.
- ✓ Acetic acid was added to reduce pH in order to prevent the unacceptable damage in the ecosystem of the Rivers.
- ✓ For this reason decision was made to construct so called "riverbed barriers" (artificially created obstacle under the water level) to stop the heavier fractions of contamination (the red mud and the precipitated materials) in the riverbed.

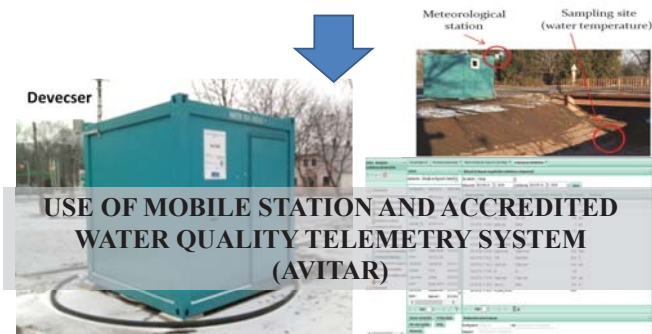
EARLY WARNING MONITORING

USE OF MOBILE STATION AND ACCREDITED WATER QUALITY TELEMTRY SYSTEM (AVITAR)
